# VEHICLE INSPECTION REPORT

**PE63NLT**

## Daf LF 45.140

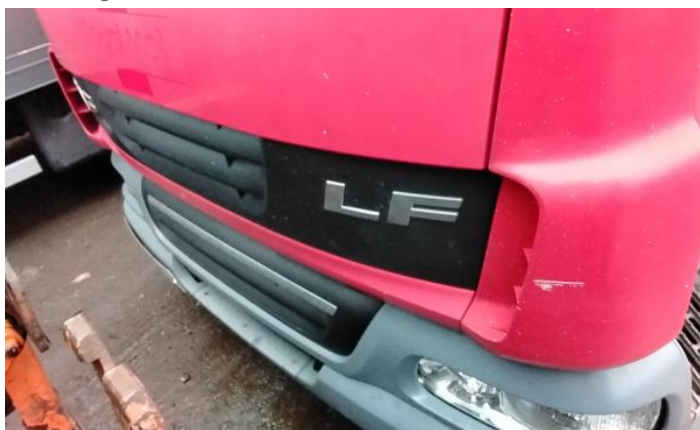
1: Bonnet  
Chipped  
Multiple Chips

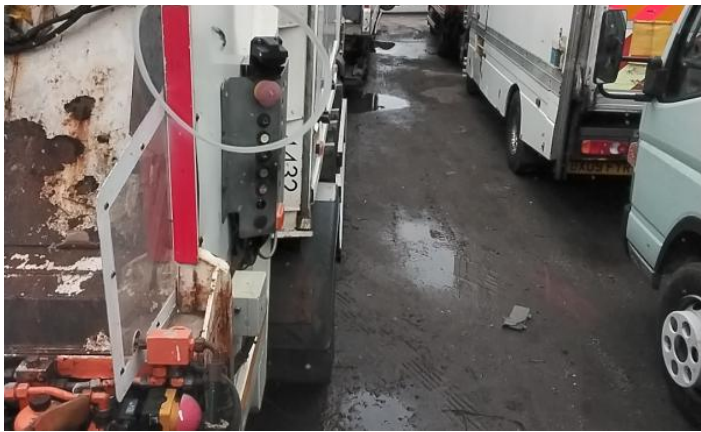
9: Screen Front  
Chipped  
Over 10mm
