# VEHICLE INSPECTION REPORT

**NK18PGF**

## Mercedes-Benz Sprinter 314 2.2 CDI

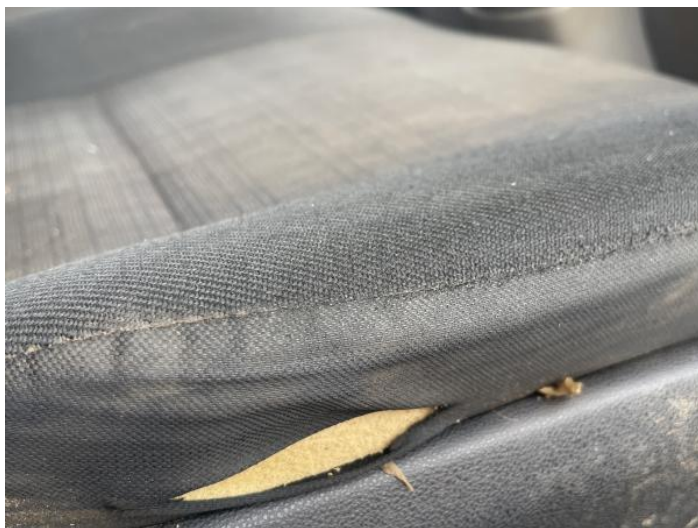
1: Seat Base Cover osf  
Torn  
Over 3mm

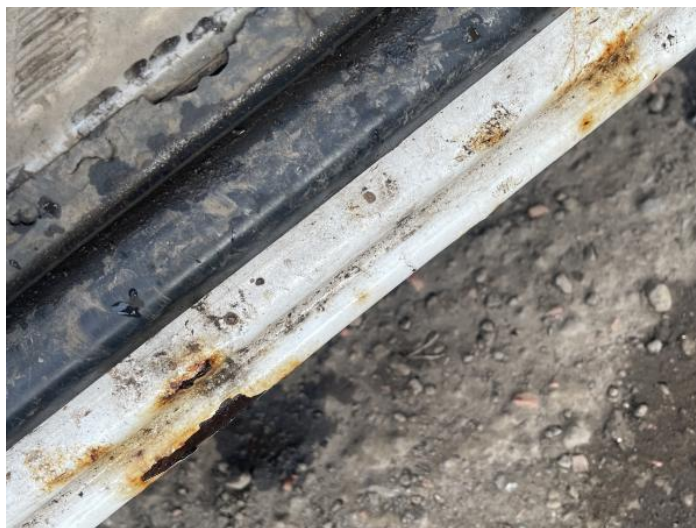
2: Sill os  
Rusted  
Over 5mm

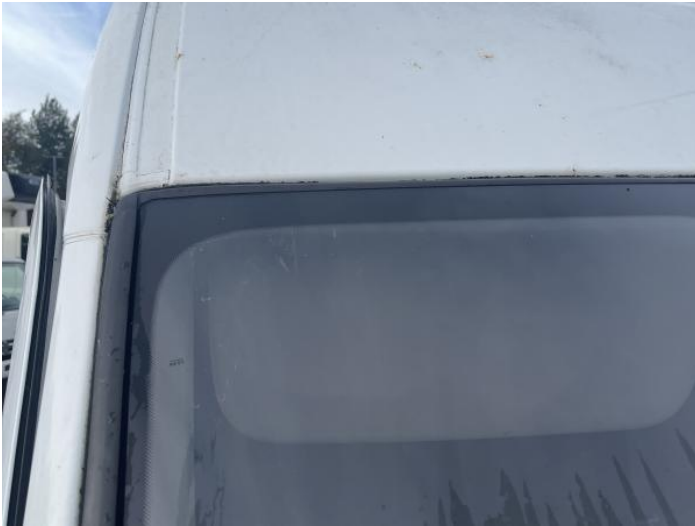
3: Roof  
Rusted  
Over 5mm

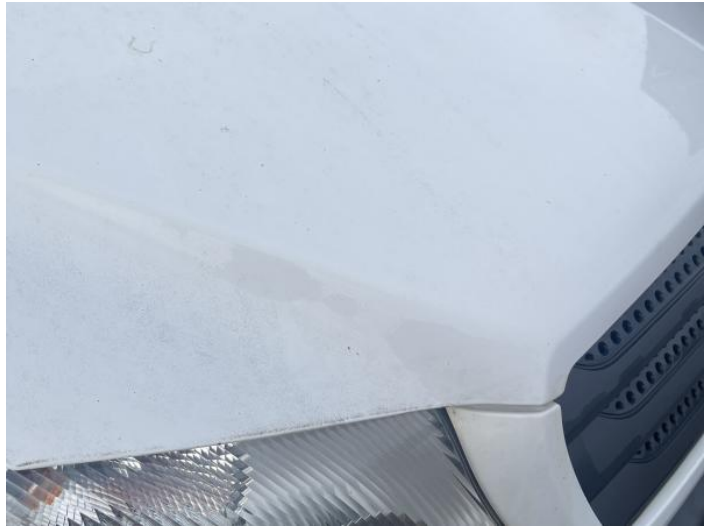
4: Bonnet  
Chipped  
1 To 5

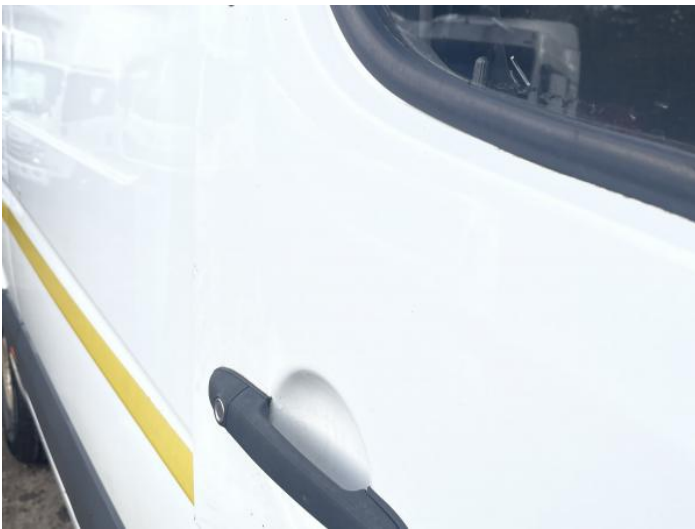
5: Door osf  
Dented  
Over 30mm

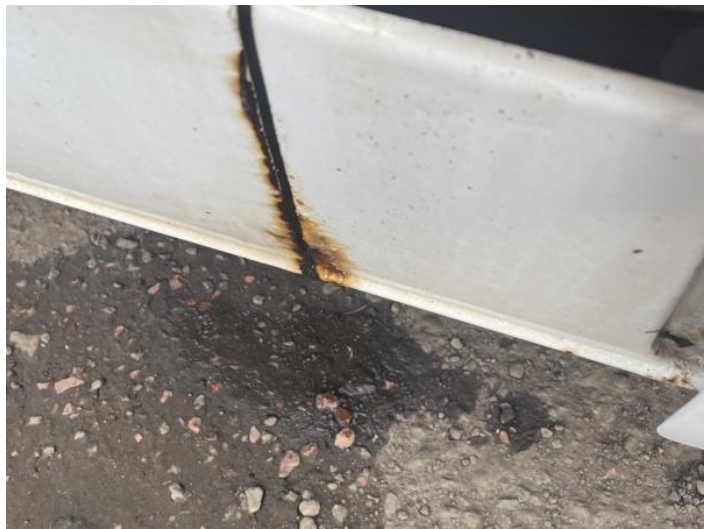
6: B Post os  
Rusted  
Over 5mm

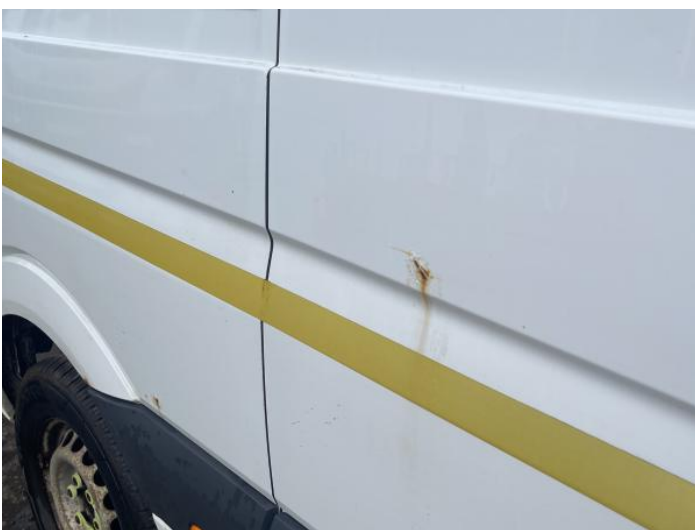
7: Qtr Panel osr  
Rusted  
Over 5mm

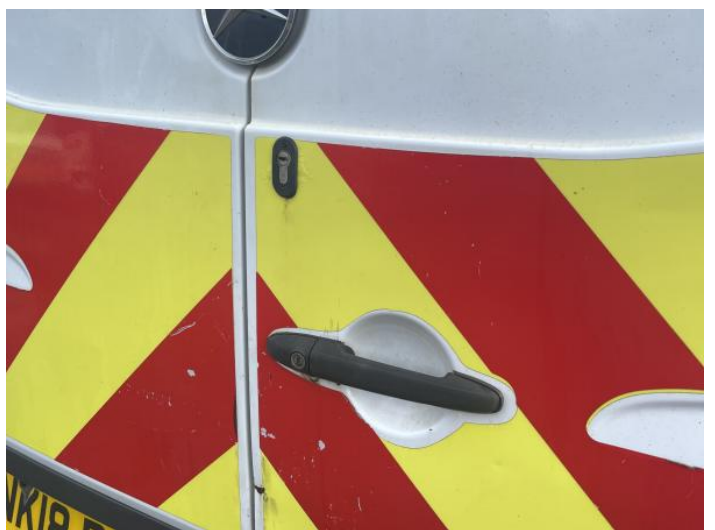
8: Tailgate  
Dented  
With Paint Damage

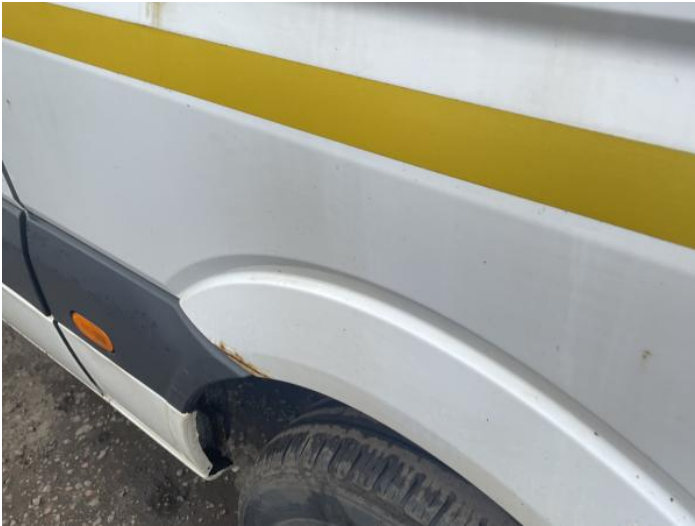
9: Qtr Panel nsr  
Rusted  
Over 5mm

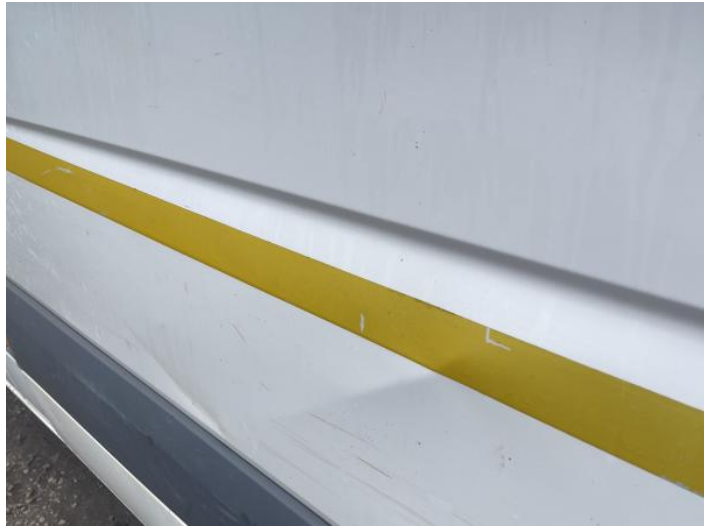
10: Door nsr  
Dented  
With Paint Damage

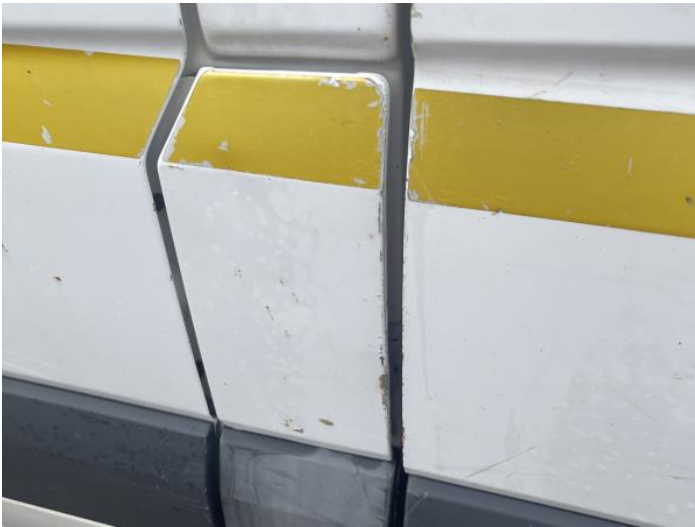
11: B Post ns  
Rusted  
Over 5mm

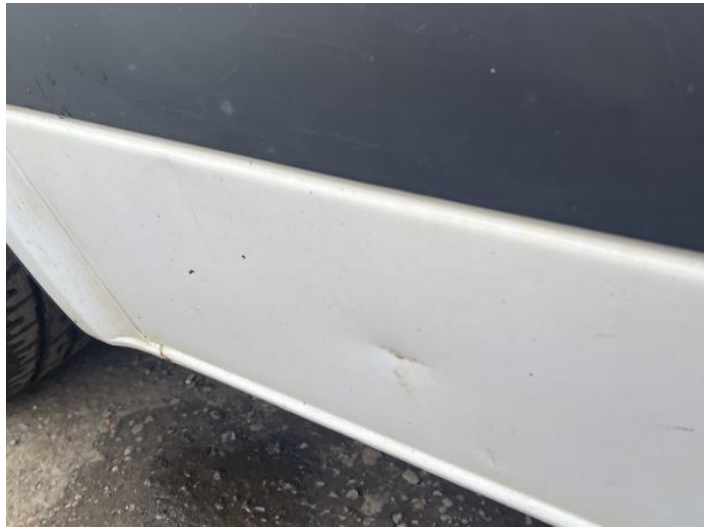
12: Door nsf  
Dented  
With Paint Damage

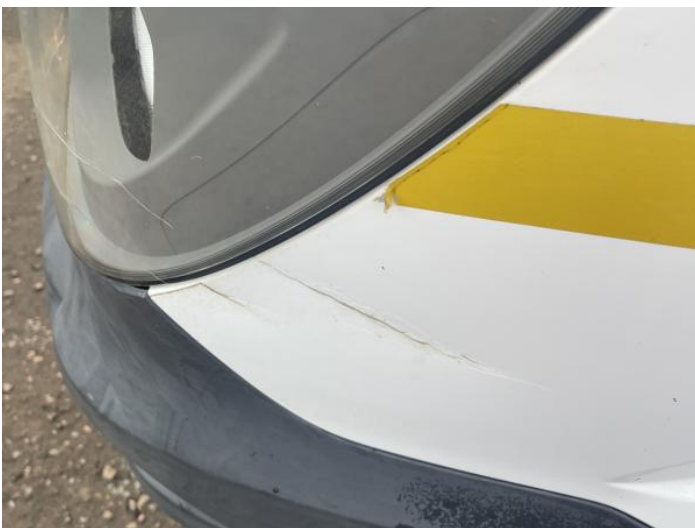
13: Wing nsf  
Dented  
With Paint Damage
