# VEHICLE INSPECTION REPORT

**PE63NKL**

## Daf LF 45.140

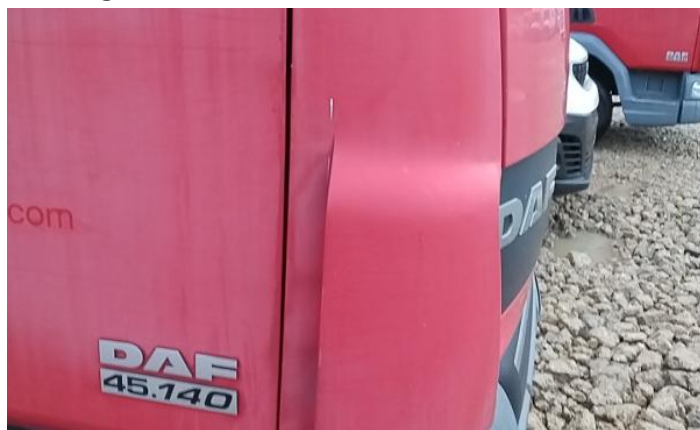
1: Wing osf  
Cracked  
Replace

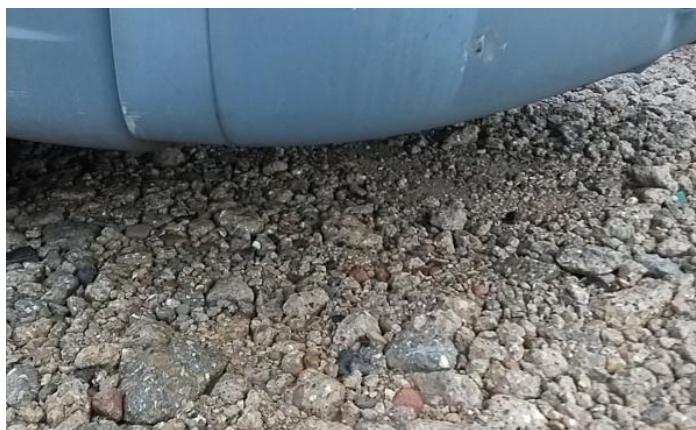
2: Bumper Front Moulding  
Scuffed (Unpainted)  
Over 100mm

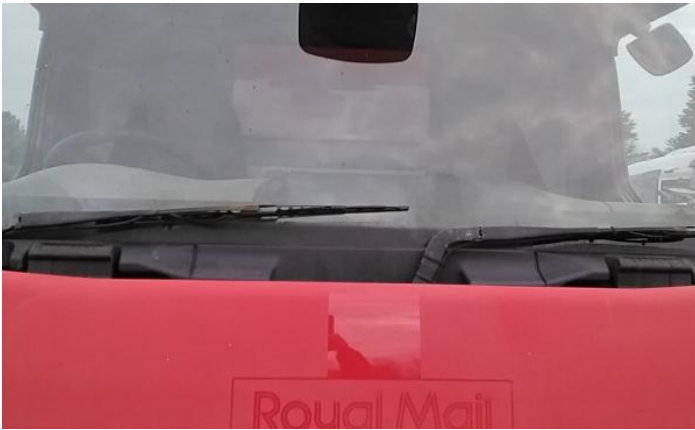
3: Screen Front  
Chipped  
UpTo 10mm

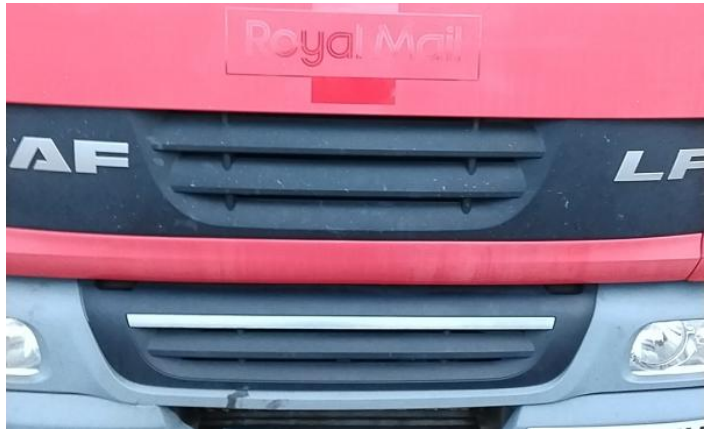
4: Bonnet  
Chipped  
Multiple Chips

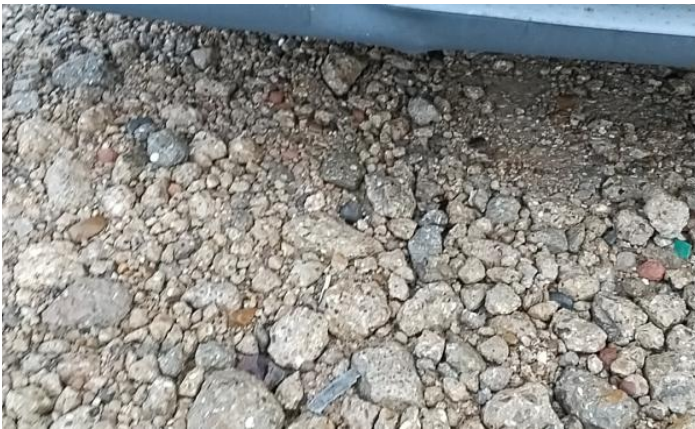
5: Bumper Front  
Dented  
Over 30mm

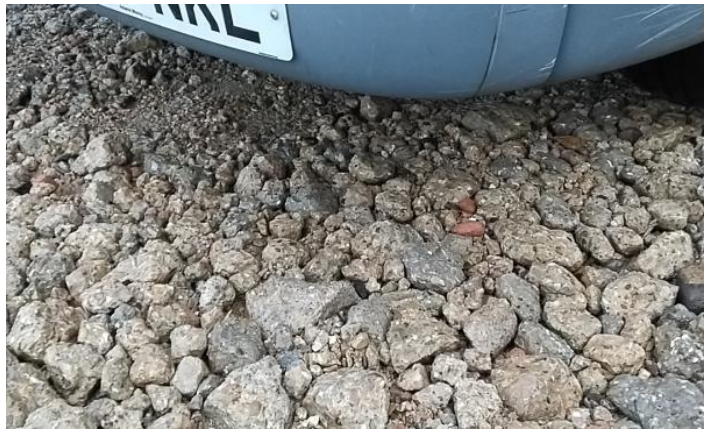
6: Bumper Front Moulding  
Scuffed (Unpainted)  
Over 100mm

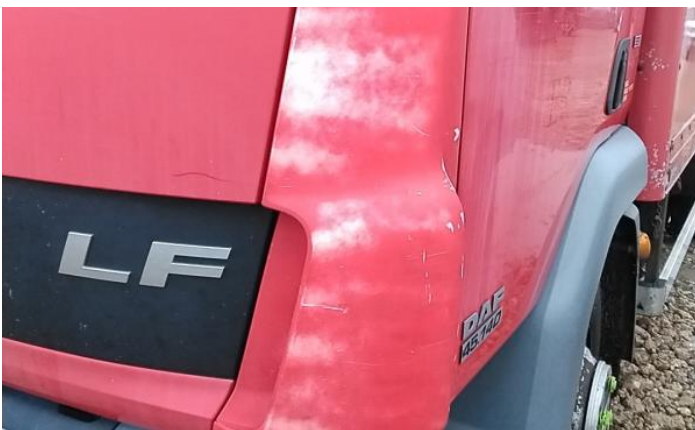
7: Wing nsf  
Poor Previous Repair  
Poor Paint

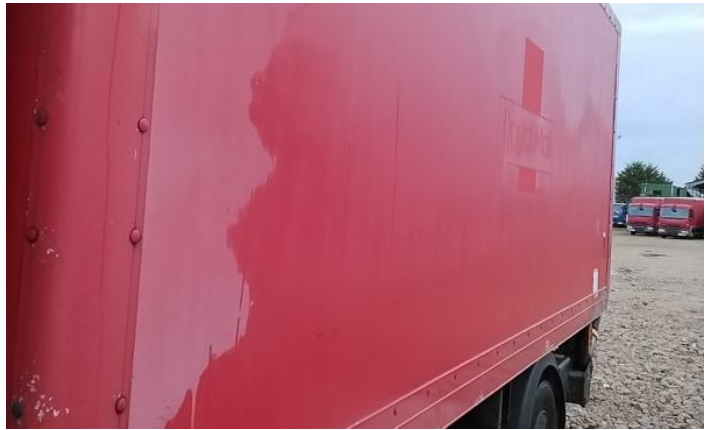
10: Panel Rear  
Scratched  
Over 25mm Thru Paint

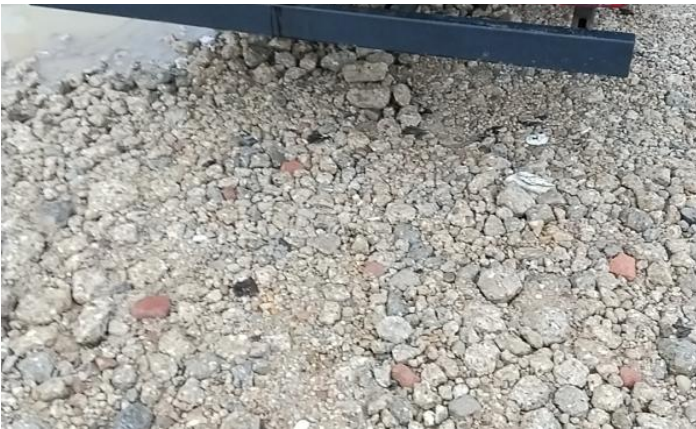
11: Bumper Rear  
Rusted  
Over 5mm

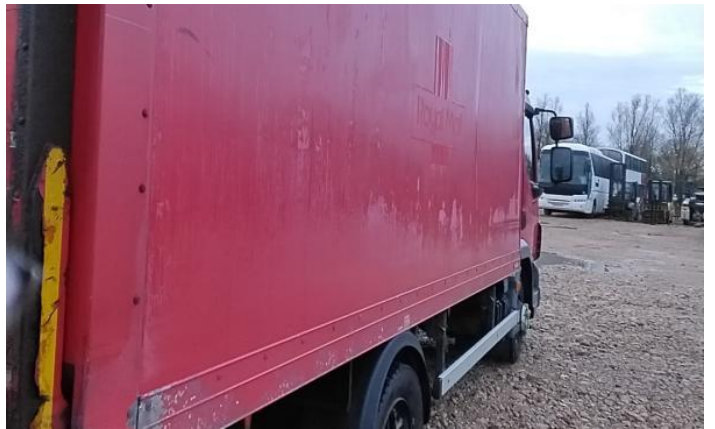
12: Panel Rear  
Scratched  
Over 25mm Not Thru Paint

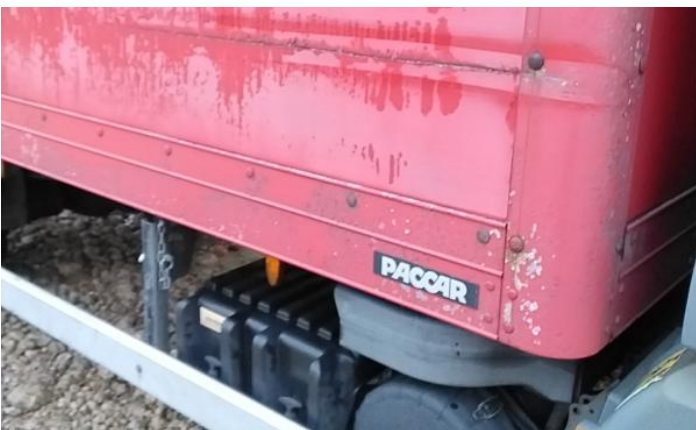
13: Panel Rear  
Cracked  
Replace

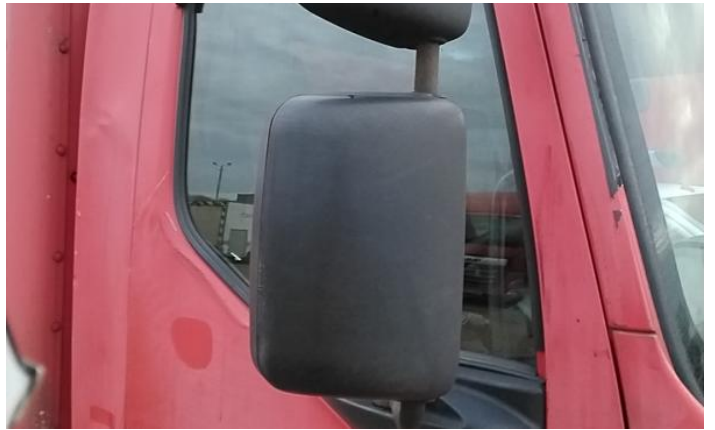
16: Door Mirror Assy osf  
Scuffed (Unpainted)  
Over 100mm

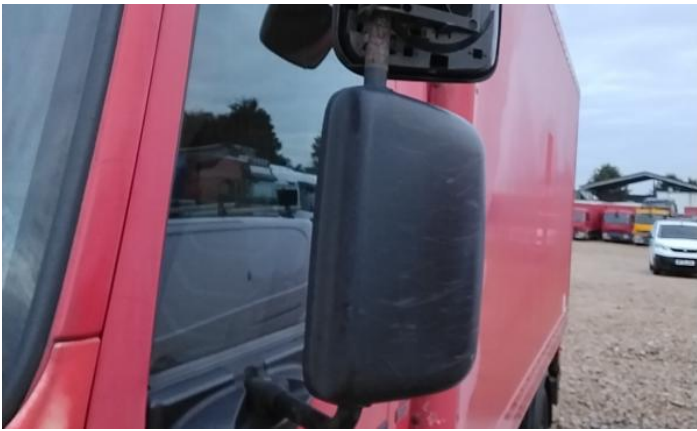
17: Door Mirror Assy nsf  
Broken  
Replace

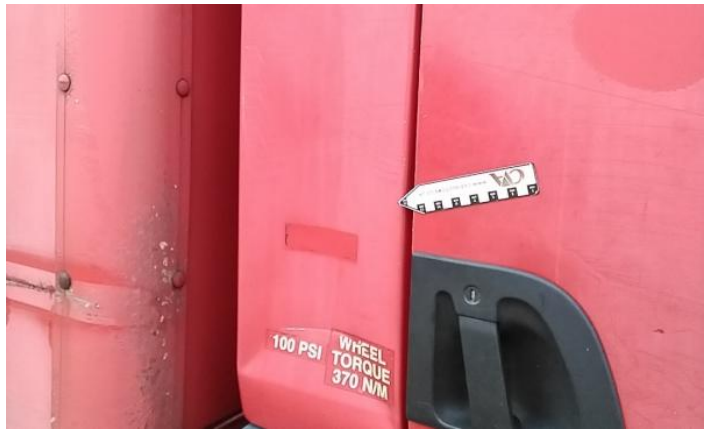
18: Door osf  
Dented  
With Paint Damage
